Buss Inspection Services, Inc.
Property Inspection Report

1234 Somewhere st, Usa st, IL 60084
Inspection prepared for: Bob Smith
Date of Inspection: 4/19/2021 Time: 930am
Weather: Overcast/rain, 45 degrees

Inspector: John Buss
Entity Lic #451.000376 , Inspector Lic #450.000133
Phone: 847-910-9515
Email: Bussinspections@gmail.com
www.bussinspections.com

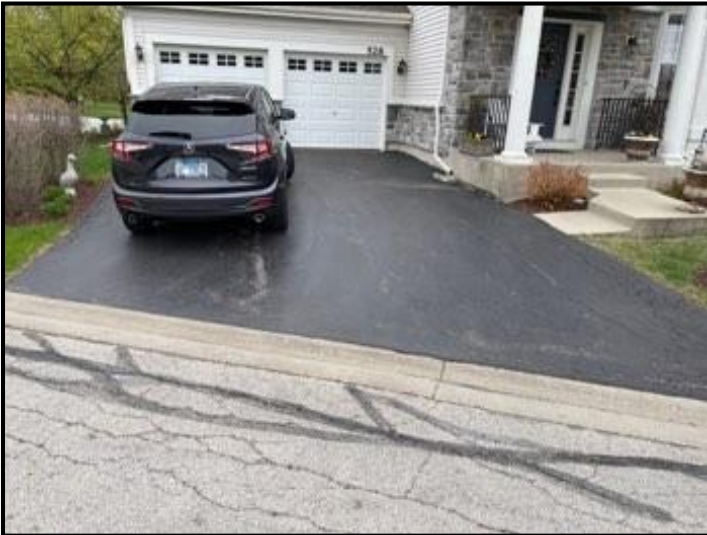
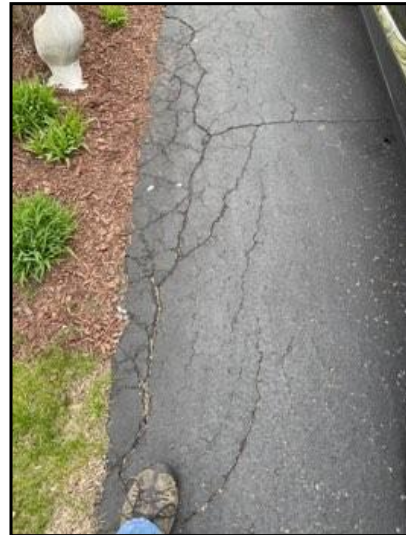
1. Driveway Condition

Observations: [Advise crack repair and sealing to extend driveway life](#)

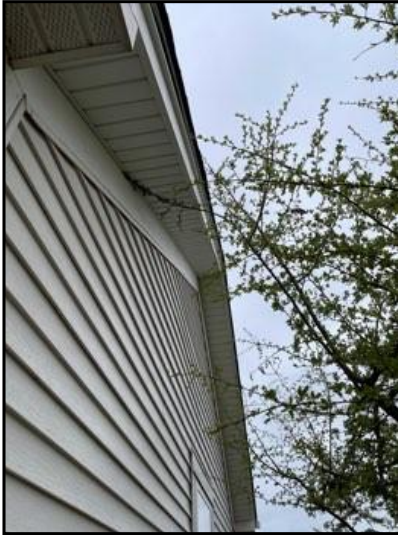
4. Vegetation Observations

Observations: **Trees branches are rubbing the roof and siding - advise maintenance**

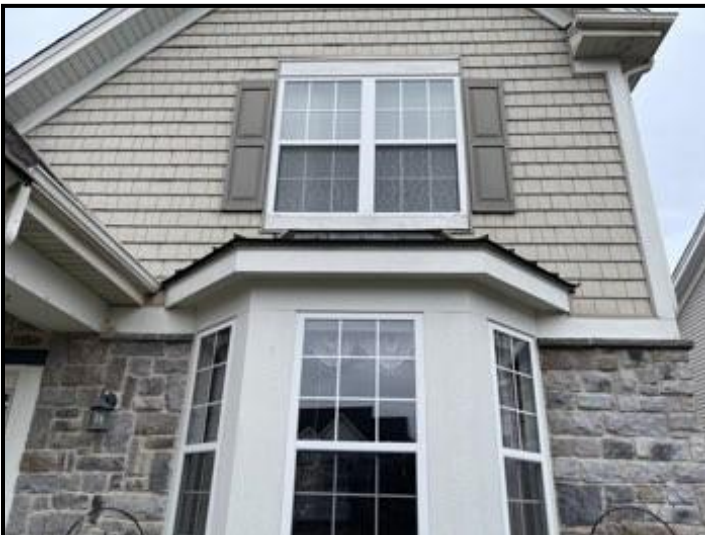
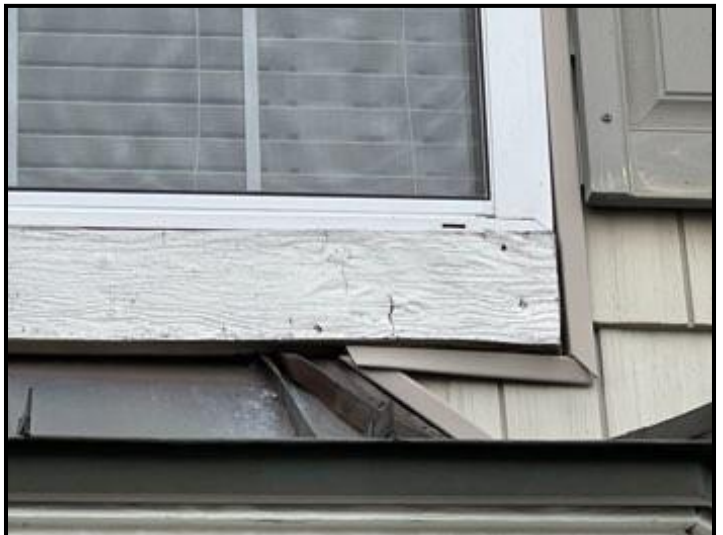
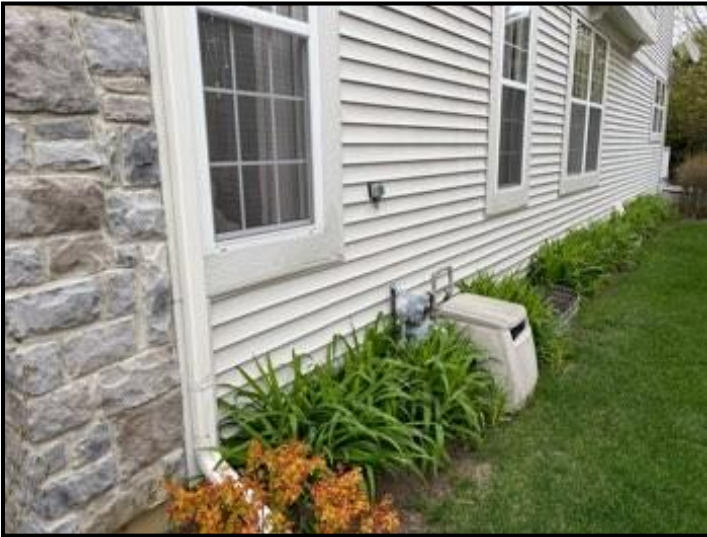
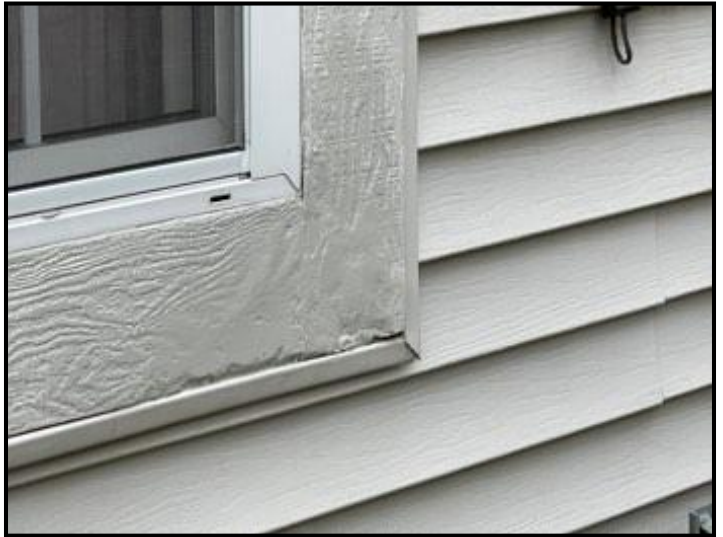
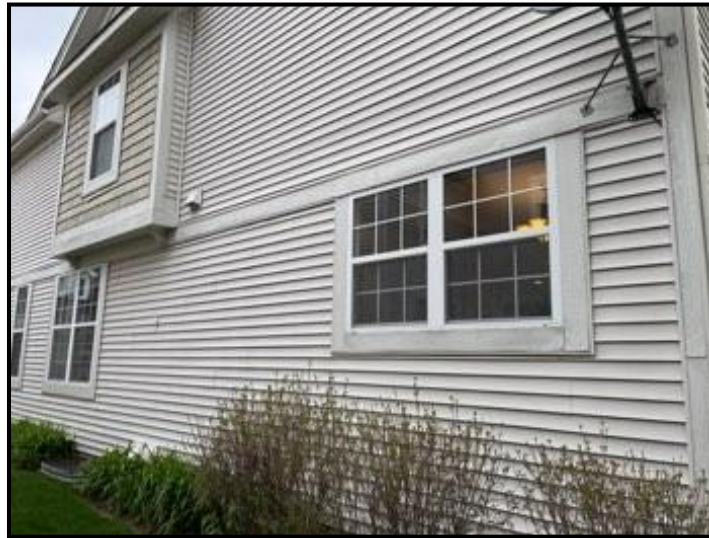
4. Exterior trim conditions

Observations: Wood. Trim wood rot was observed in the following locations: Window trim wood rot was viewed at the southwest second-floor window at the bottom right side >>>>> Window trim wood rot was viewed at the South West first floor window at the right lower side near the previous trim repairs >>>>> Window trim wood rot was viewed at the south exteriors lower fascia board near the bay window wall vent >>>>> and also at the south east lower window at the right side - advise further evaluation and repair by a qualified trim carpenter

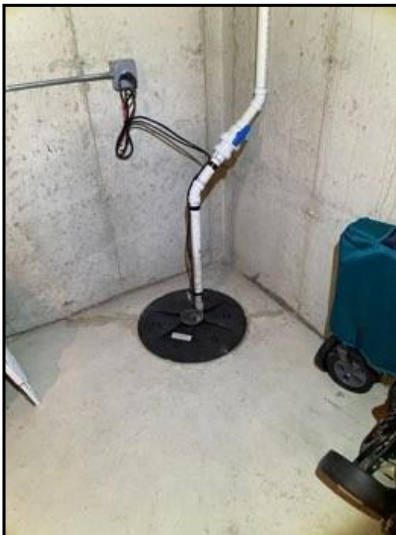
6. Sump pump

Observations: The sump pump functioned properly when tested. Advise installation of battery back up sump system

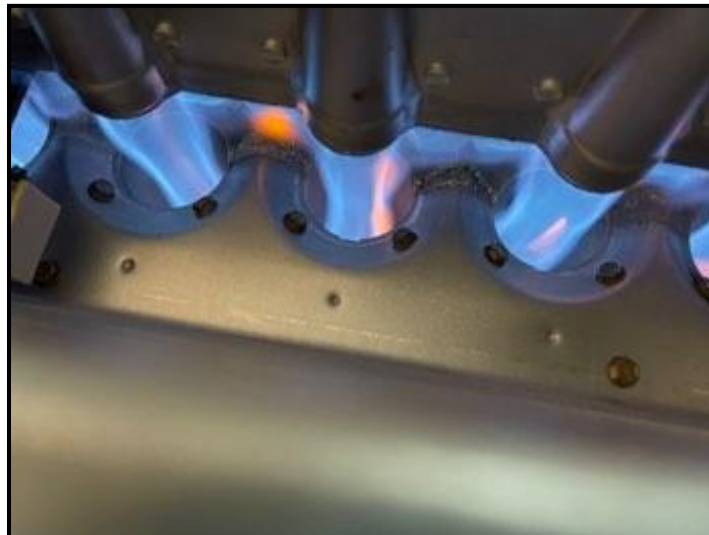
3. Furnace Condition

Observations: Functioned properly when tested. The heat exchanger is not fully visible. **Furnace is dirty and does not appear to have been serviced in the recent past - Advise servicing by a qualified hvac contractor**

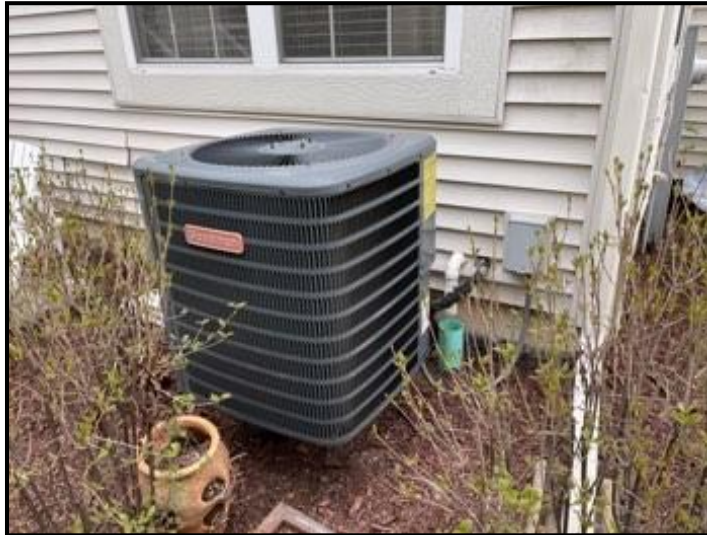
2. Condenser observations

Observations: The **A/C** system could not be tested due to cold exterior conditions, The a/c system should only be tested when exterior temperatures are above 60 degrees to prevent damage to the condenser equipment - Advise testing when weather permits

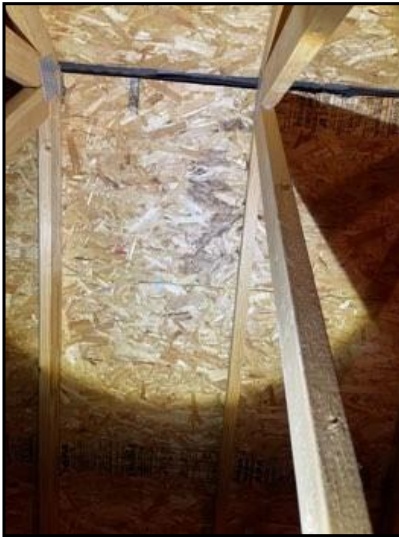
6. Attic Conditions

Observations: A water stain was viewed in the attic on the attic roof sheathing, this stain is located beneath the ridge vent above the attic hatch - advise further evaluation and repair by a qualified roofing contractor
